**CALSPAN ON-SITE AIR BAG/ARM FRACTURE
CRASH INVESTIGATION**

CALSPAN CASE NO. 94-42

VEHICLE #1 - 1991 DODGE SPIRIT

VEHICLE #2 - 1985 FORD TEMPO GL

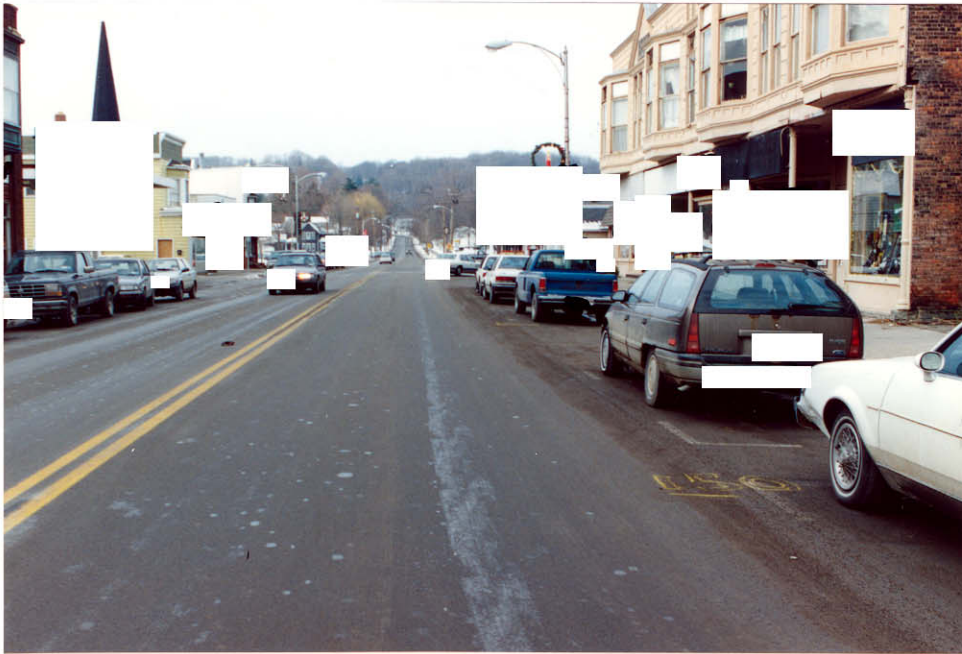
6. Approach trajectory of Vehicle #2 - 60 meters (200') prior to the POI.

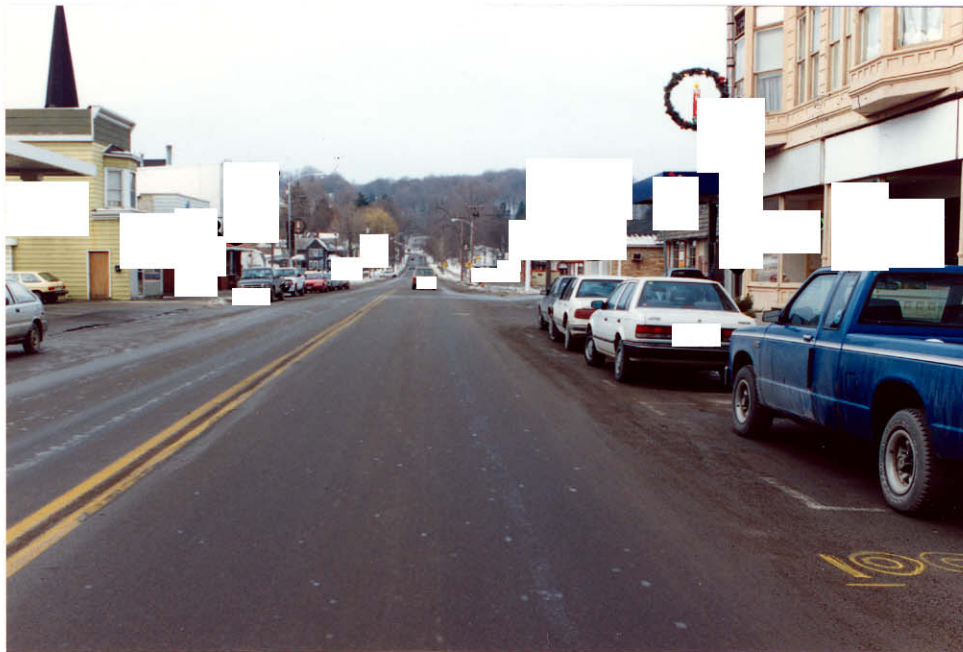
7. Approach trajectory of Vehicle #2 - 45 meters (150') prior to the POI.

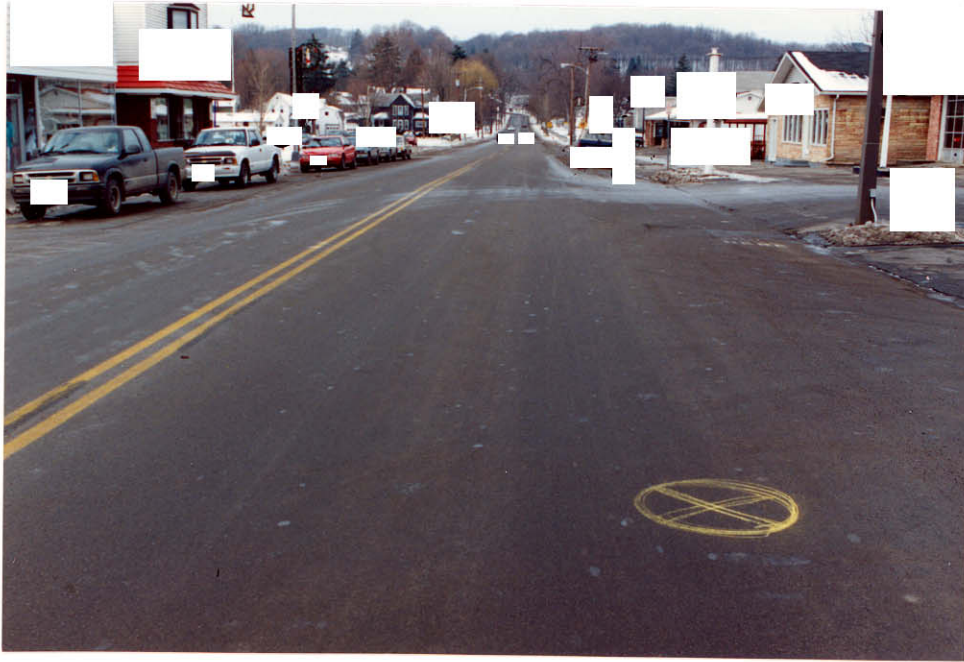
10. Approach trajectory of Vehicle #2 - 7.5 meters (25.0') prior to the POI.

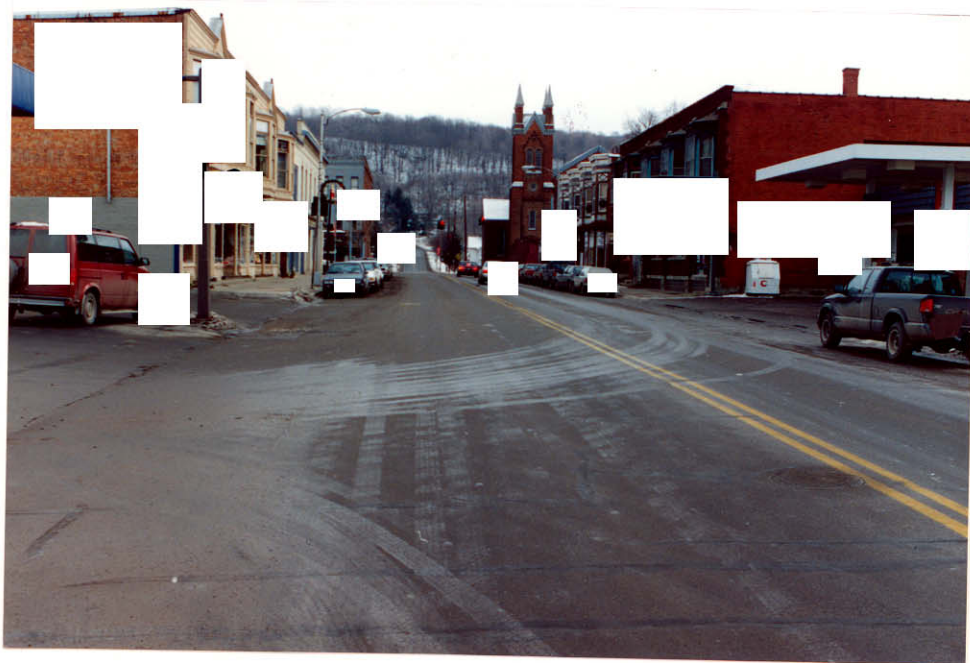
11. View of Vehicle #2's trajectory at POI and FRP.

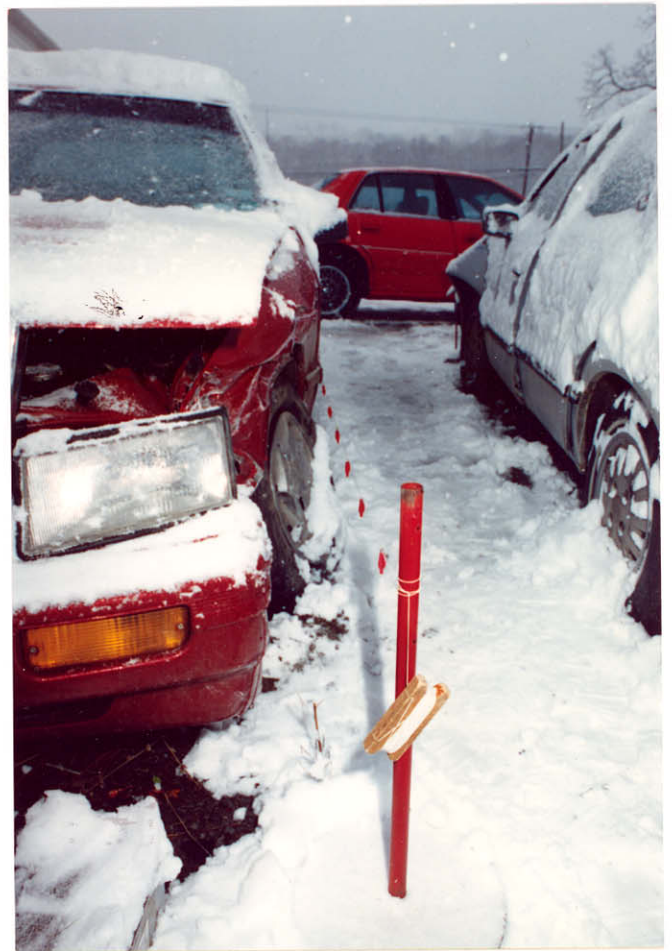
15. A longitudinal view of the left side plane showing the extent of lateral crush.

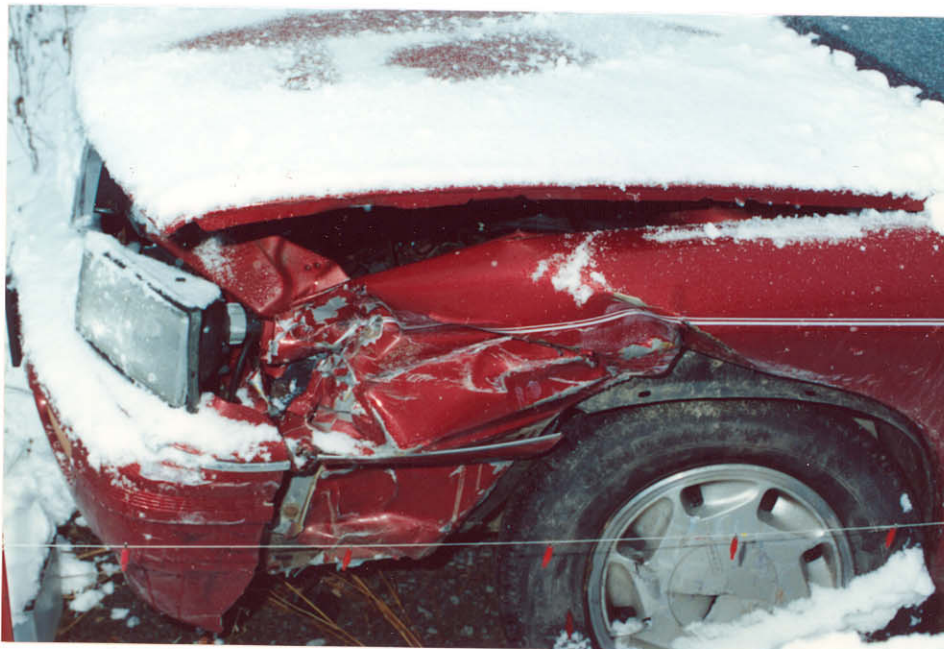
17. A view of the left front corner of Vehicle #1 showing the area of contact damage.

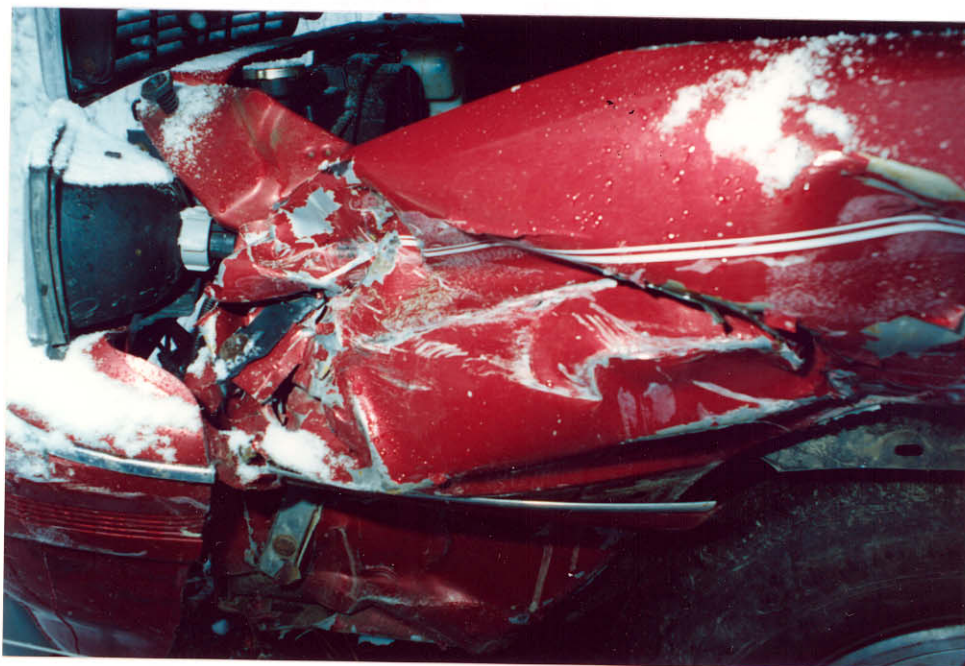
18. A lateral view of the left front fender showing the area of contact damage.

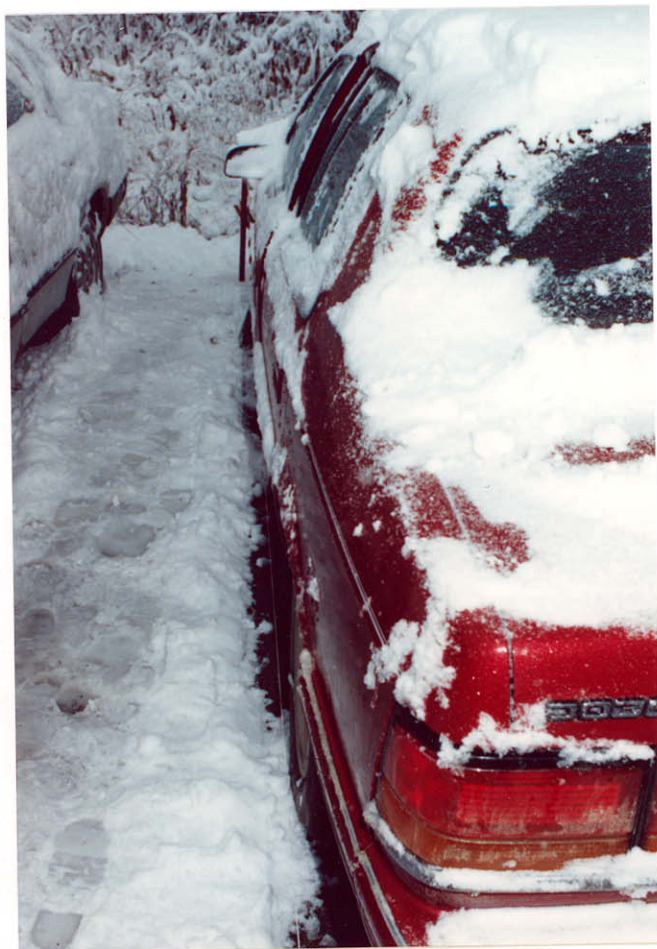
23. Close-up view of the sideslap contact pattern.

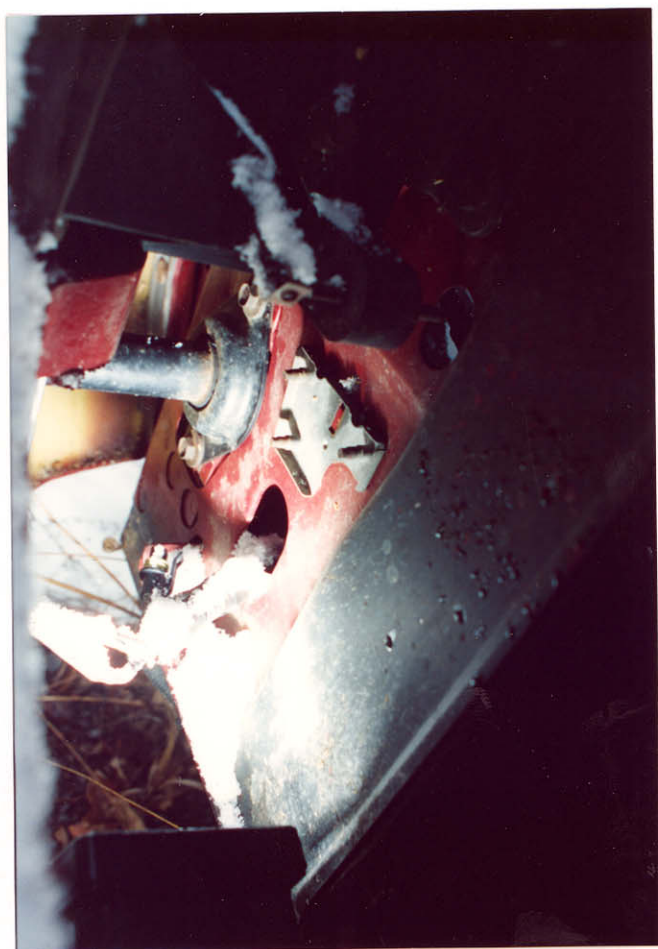
32. View of the right front bumper EAD indicating no compression.

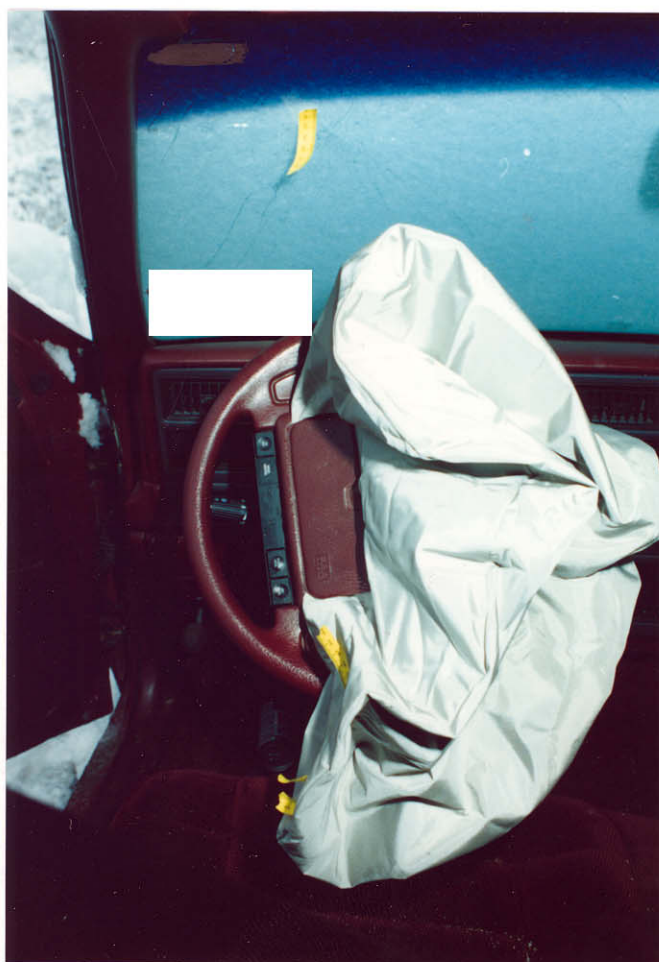
33. Lateral view of Vehicle #1's interior taken from the left side of the vehicle.

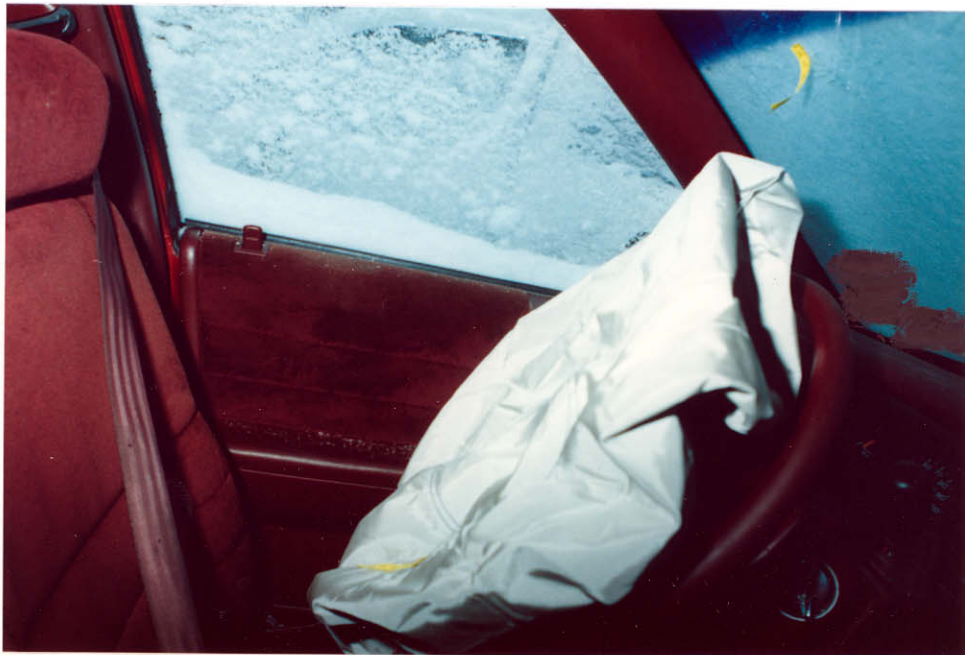
41. View of a light red transfer (i.e., lipstick) in the upper right quadrant of the air bag.

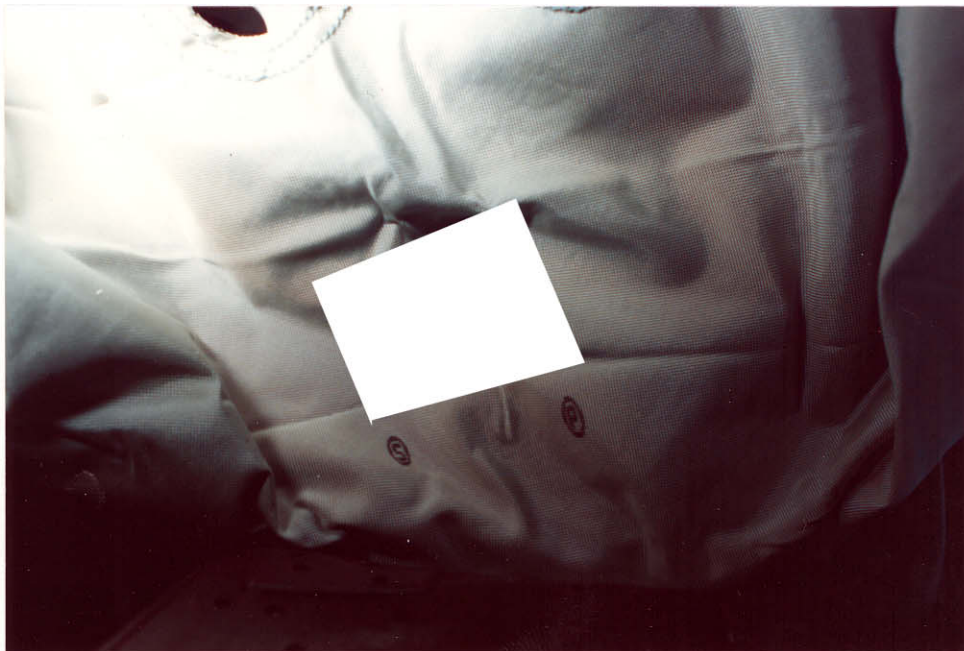
43. View of the vent ports located on the top instrument panel side of the air bag.

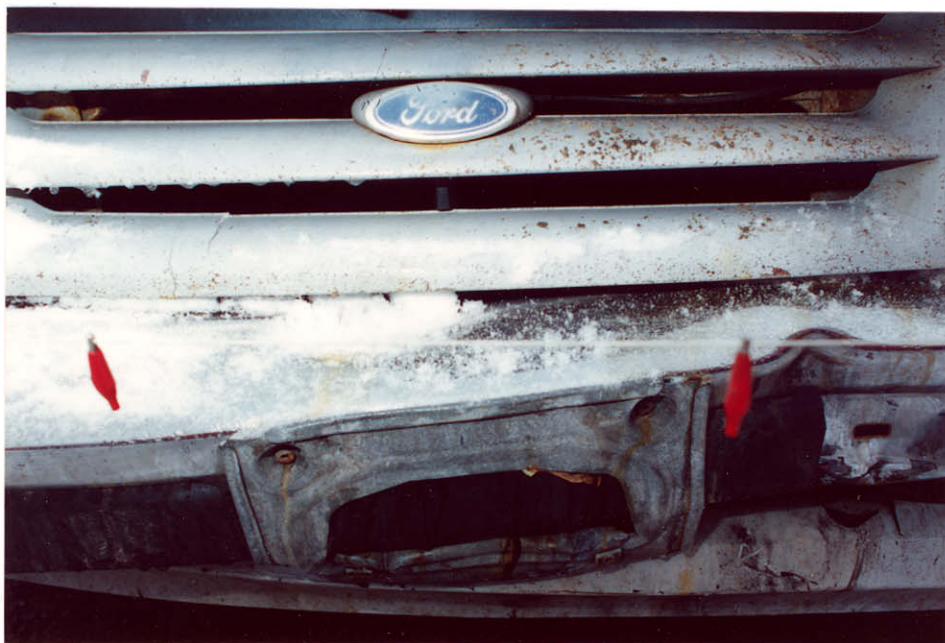
55. Frontal view of the Vehicle #2 (1985 Ford Tempo GL) showing contact damage resulting from the impact with Vehicle #1.

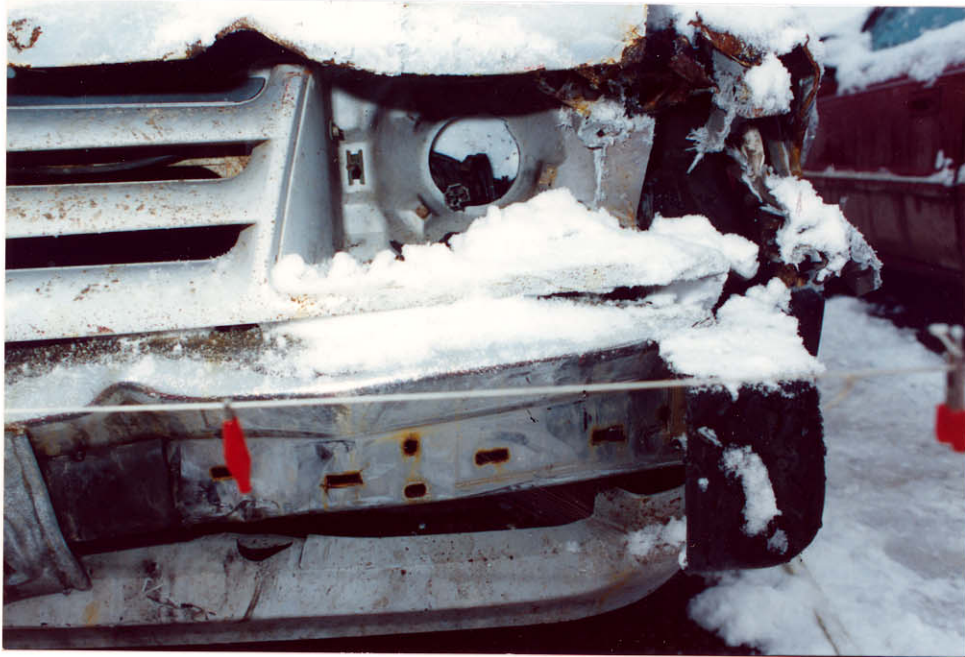
56. Close-up view of the contact damage in the center third of the vehicle's frontal plane.

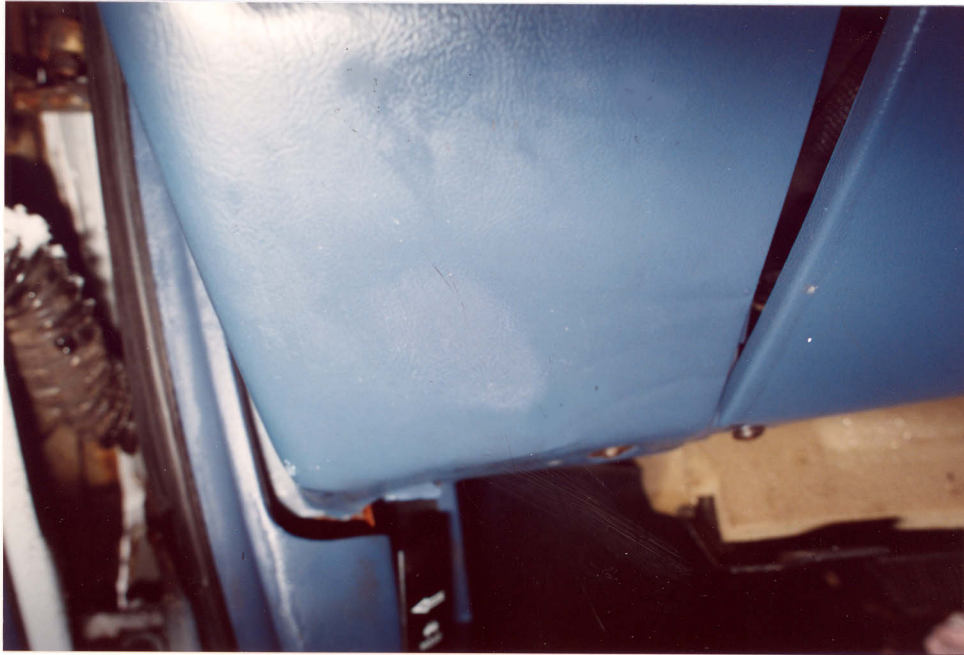
72. View of the lower instrument panel showing a scuff mark below the headlight switch from the driver's left knee.
